Title: Failures And Maintainance Report On Bituminus Road In East Godavari District

Failures And Maintenance Report On Bituminous Road In East Godavari District

Abstract

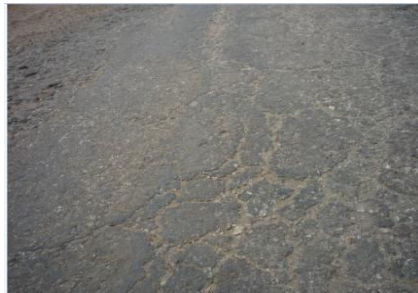
Fig 3.1 Existing Pavement of Alligator Cracking.

- A. Alligator Cracking** Alligator cracking is characterized by interconnected or interlaced cracks in the wheel path, forming a series of small polygons, (generally less than 1 foot on each side)

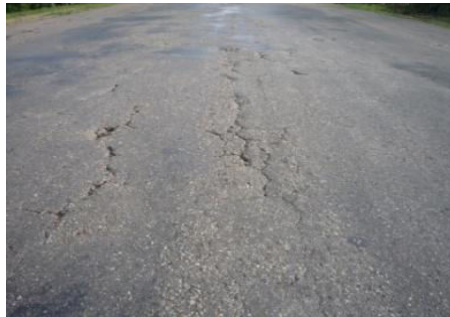
Fig 3.2 Existing Pavement of Longitudinal Cracking.

Longitudinal cracks are non-load-associated cracks. Longitudinal cracks are single cracks approximately parallel to the centerline.

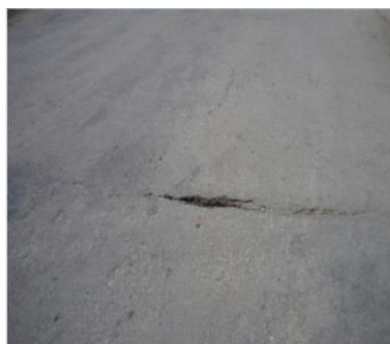
Fig 3.3 Existing Pavement of Transverse Cracking.

Transverse cracks are non-load-associated cracks. Transverse cracks appear approximately at right angles to the centerline.
